THE 'NEW EYES' OF SCROVEGNI CHAPEL

BY MICHELE TREVISANELLO

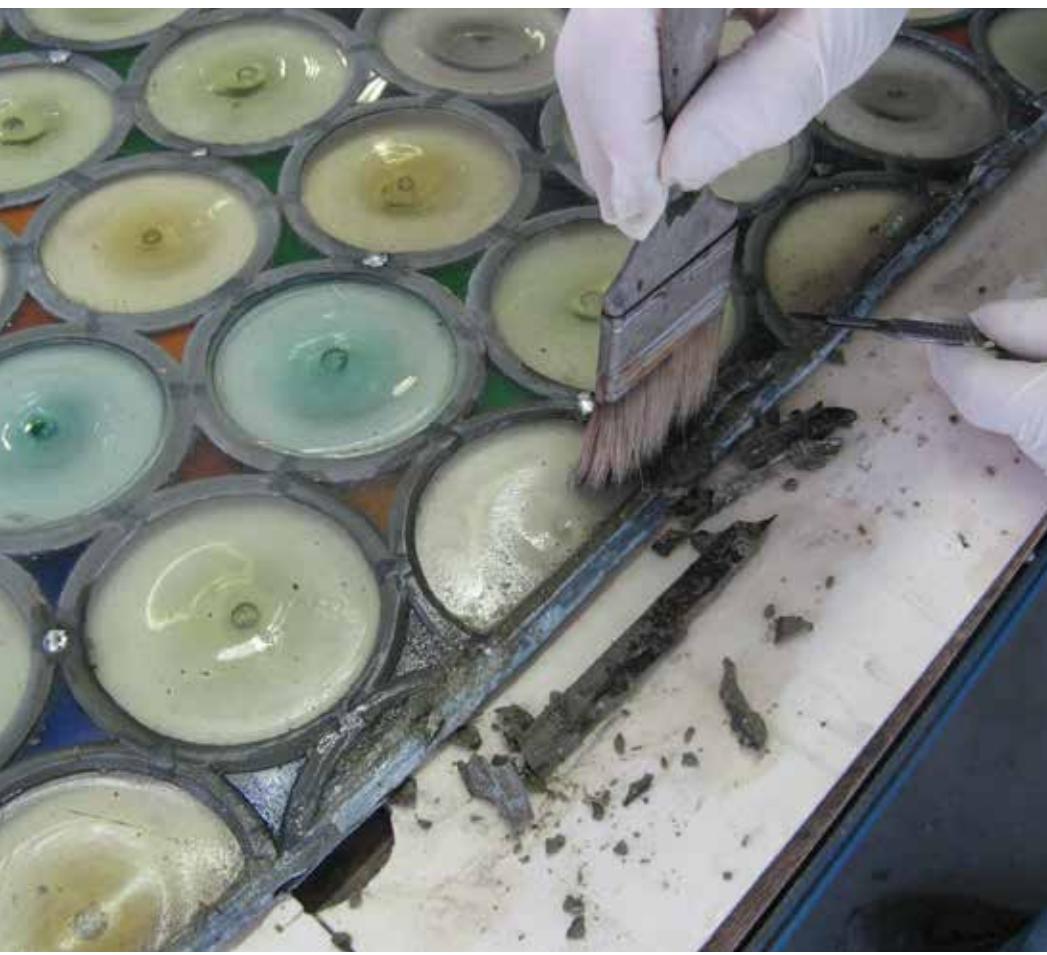
Part of the cleaning processes.

Analyses revealed that welded lead was particularly deteriorated; indeed its ends were covered by a reddish oxidation product. Although the cause of the rust could not be pinpointed, we believe it is probably due to the fact that lead was not cleaned after being welded and there was acid in the welding. The components were cleaned with White Spirit to remove the oxidation from the surface, which did not allow the natural oxidation of the lead underneath. The cleaning trial with isopropyl alcohol was particularly successful, since it was possible to remove both the upper dusty patina and the stains of biological origin. White Spirit was also used to remove the stains of black varnish (used to coat the external grids) and the brown stains (a product similar to Fidoil).

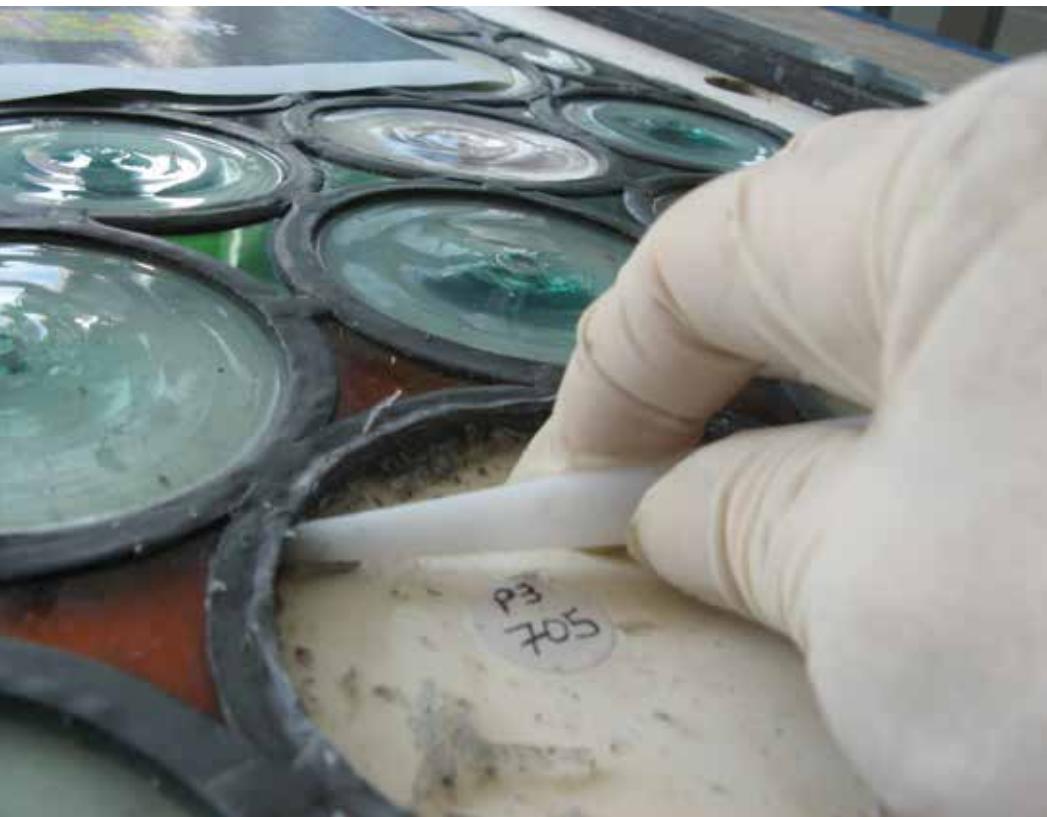
Part of the new restoration involved the removal of inadequate restoration attempts from years earlier.

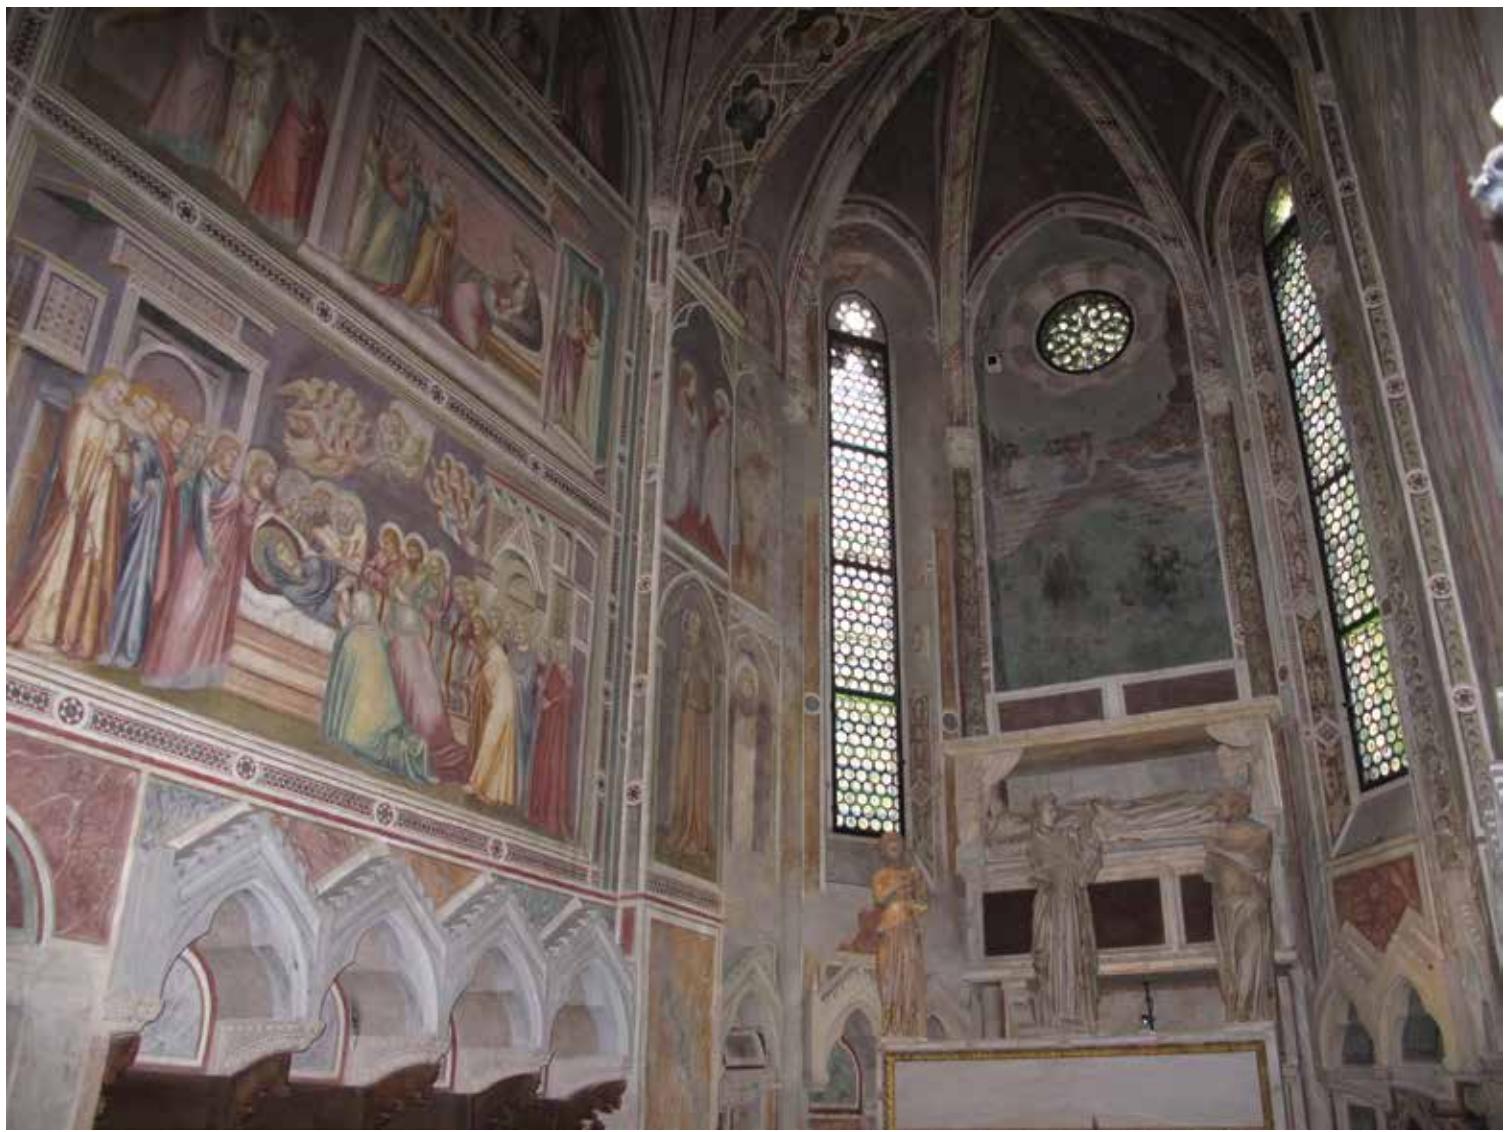
Restored apse windows.

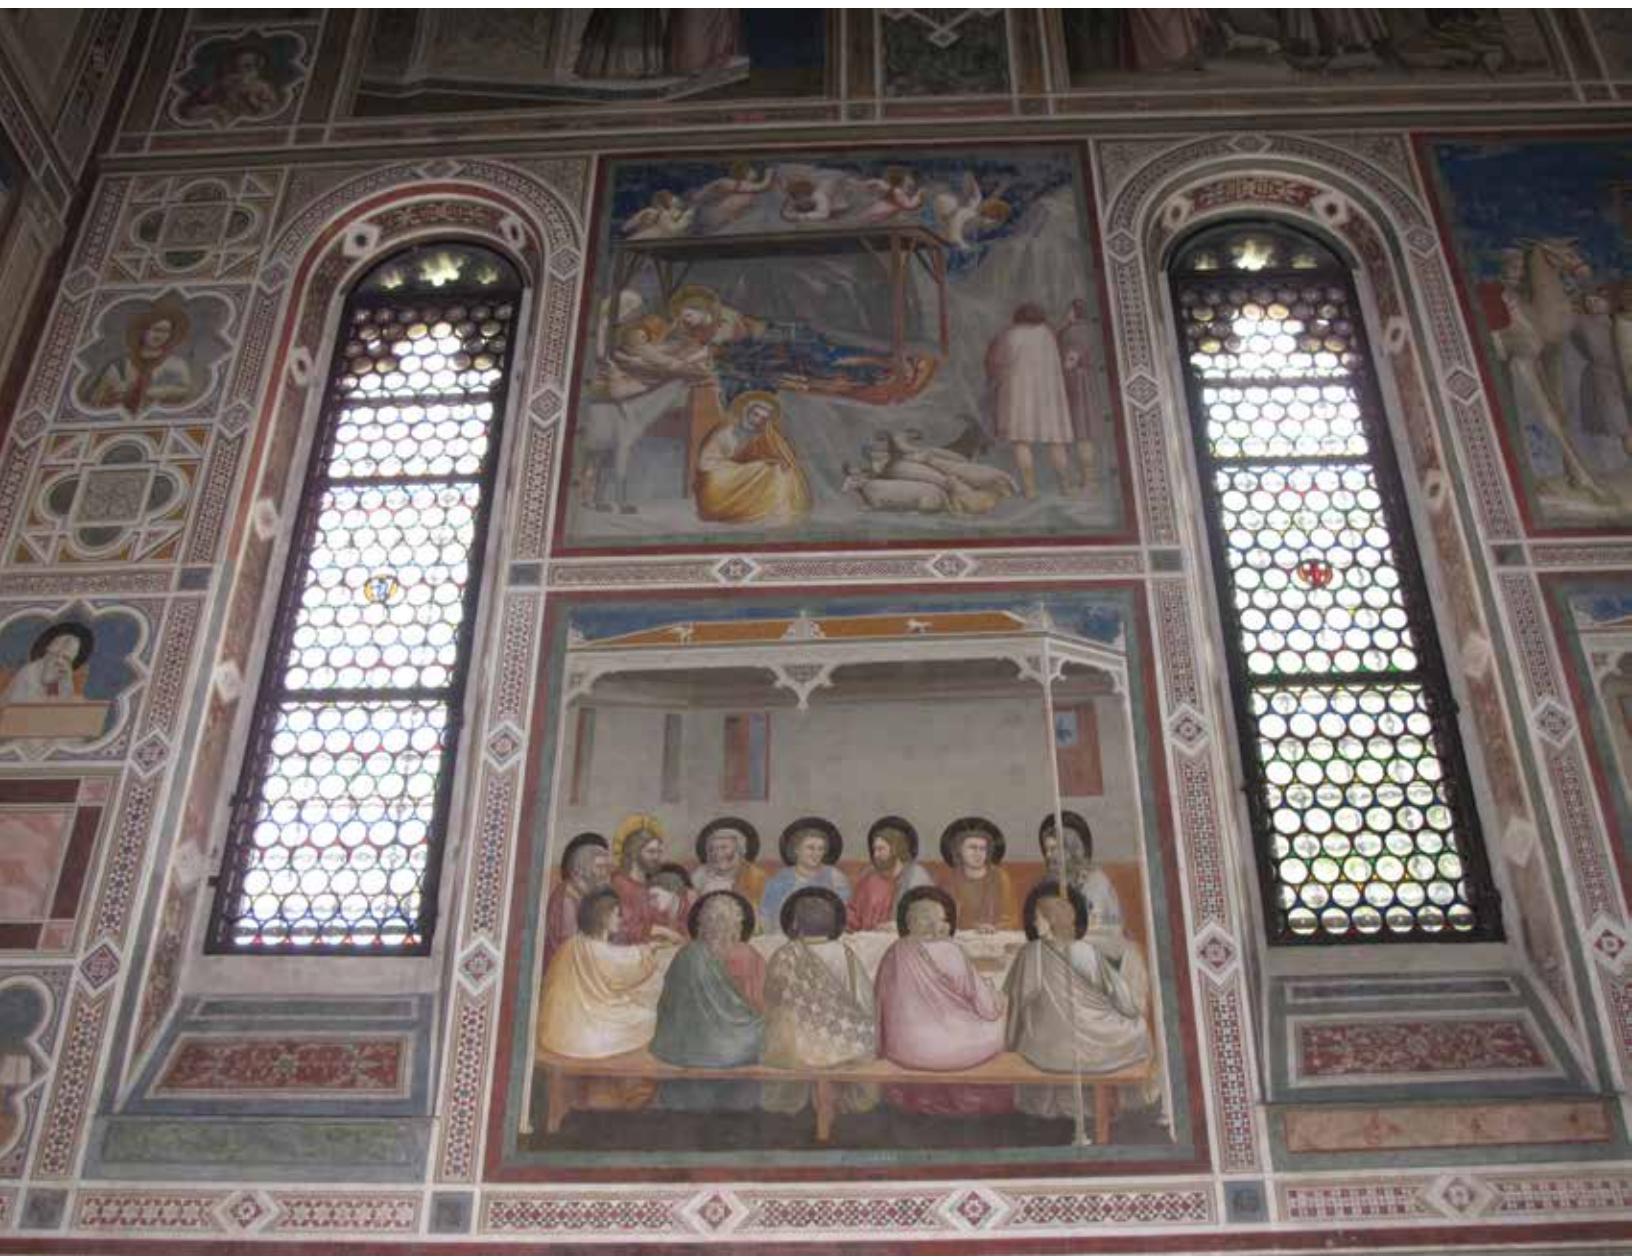
Two of the six restored windows in the nave.
